**Flood Control Project Maintenance
Levee Inspections**

Maintenance Issue Types Only, Levee Inspection Report By Mile - Fall 2018

Sacramento Maintenance Yard Willow Slough Bypass

Waterway	Bank	Unit Miles	Inspection Start/End	Inspector
Unit No. 01 Willow Slough Bypass or North Levee	Left	5.05	09/05/2018 09/05/2018	Zach Jojola

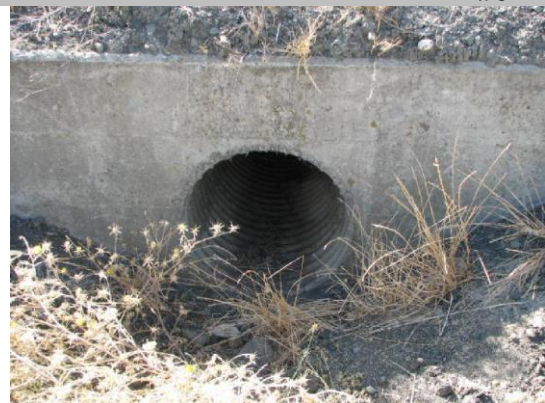
Photo 2 of 3 : UCIP_FA_2018_44907_22893.jpg

Landside view- pipe and headwall closer view

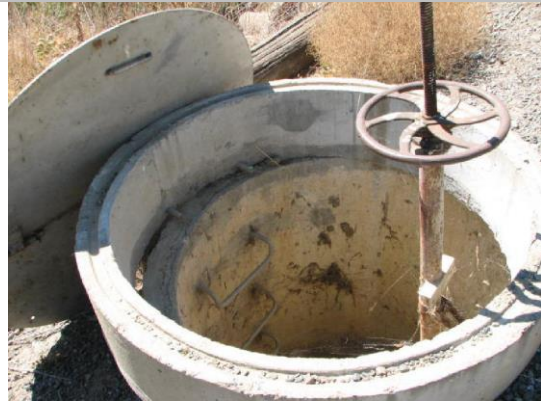
Photo 3 of 3 : UCIP_FA_2018_44937_22948.jpg

Waterside view- concrete manhole.

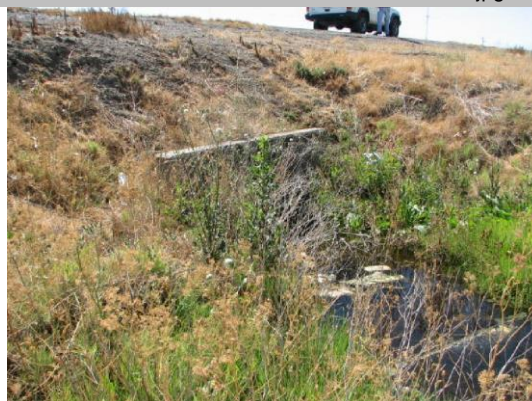
Photo 1 of 3 : UCIP_FA_2018_44942_22962.jpg

Landside view- inlet structure

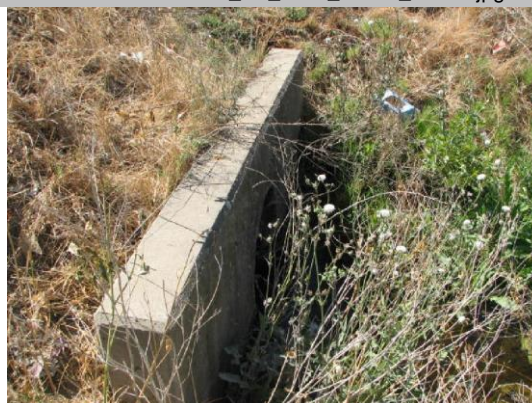
Photo 2 of 3 : UCIP_FA_2018_44942_22961.jpg

Landside view- concrete headwall

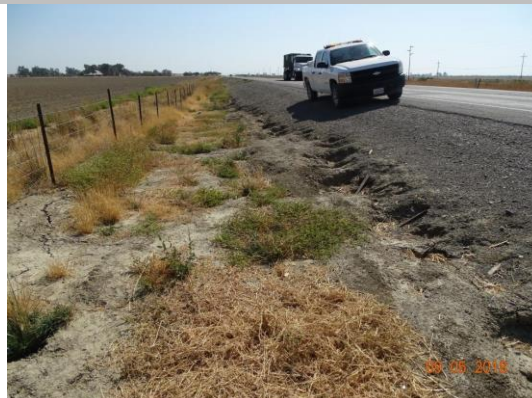
Photo 2 of 3 : FA_2018_ST0012_295_10_20180905_00006.jpg

Additional view of the erosion on the landside slope. Fall 2018.

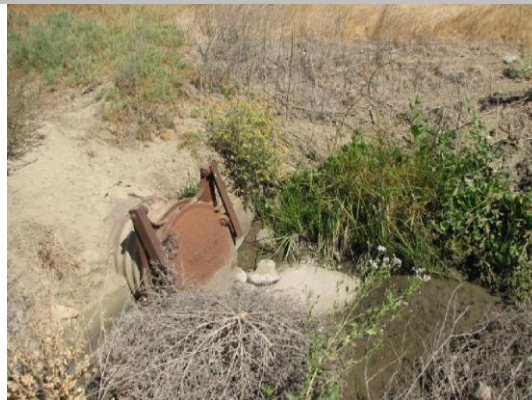
Photo 1 of 3 : UCIP_FA_2018_44943_22967.jpg

Waterside view- pipe and flap gate.

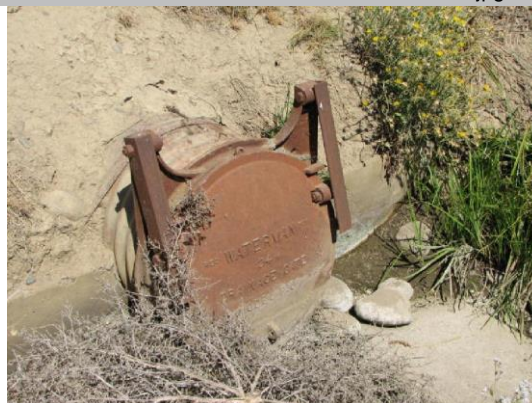
Photo 2 of 3 : UCIP_FA_2018_44943_22970.jpg

Waterside view- pipe and flap gate (close view).

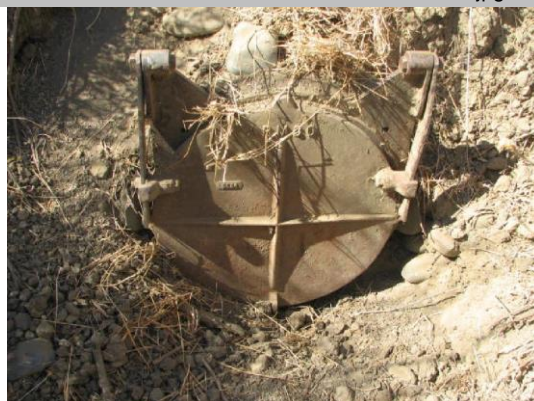
Photo 1 of 3 : UCIP_FA_2018_13725_22470.jpg

Waterside view- flap gate and CM pipe

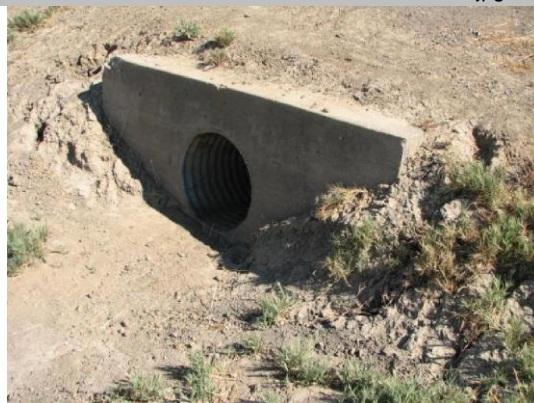
Photo 2 of 3 : UCIP_FA_2018_13725_22469.jpg

Landside view- concrete headwall and pipe

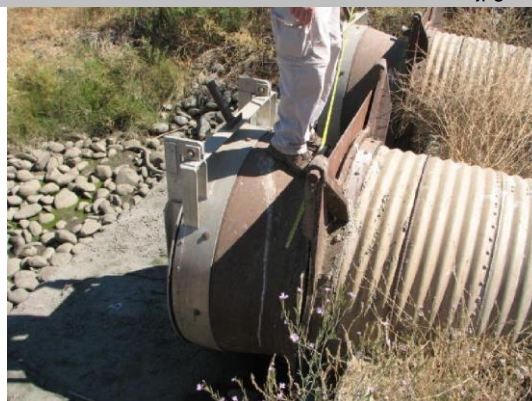
Photo 3 of 3 : UCIP_FA_2018_45294_22792.jpg

Waterside view- 42-inch steel pipe and flap gate.

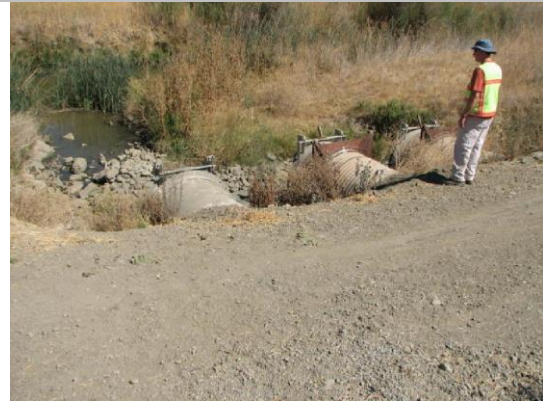
Photo 1 of 3 : UCIP_FA_2018_45295_22794.jpg

Waterside overview- far right 42-inch pipe.

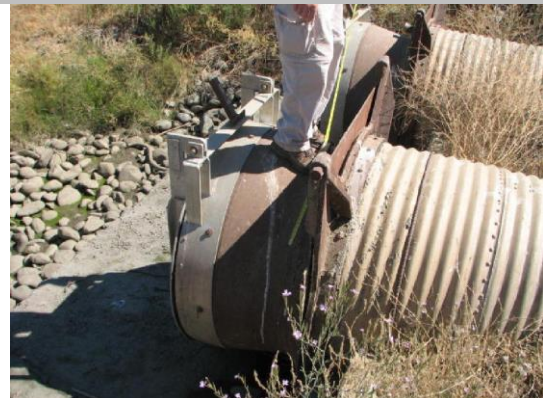
Photo 2 of 3 : UCIP_FA_2018_45295_22793.jpg

Waterside view- 42-inch steel pipe and flap gate (right).

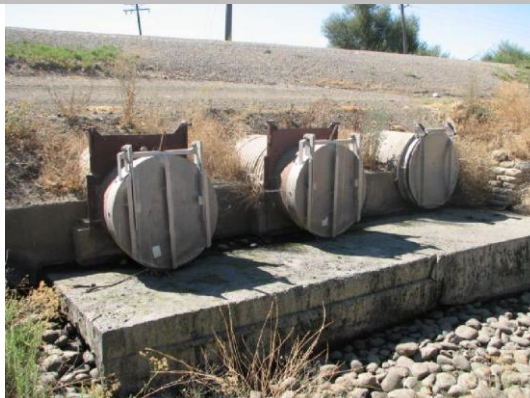
Photo 3 of 3 : UCIP_FA_2018_45295_22796.jpg

Waterside overview- outlet structure.

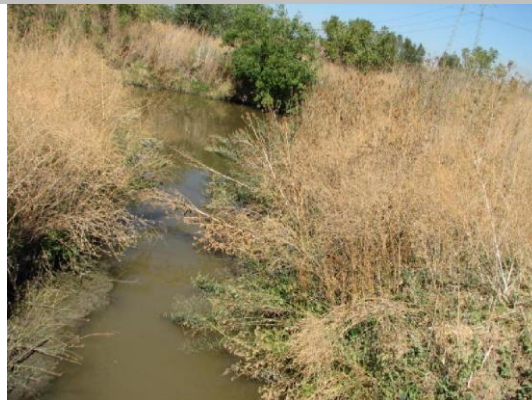
Photo 3 of 3 : UCIP_FA_2018_45302_22847.jpg

Waterside view- overview
